SUBJ: RCRA Compliance Evaluation Inspection
Valmont Coatings Inc. dba Valmont Birmingham Galvanizing
EPA ID Number: ALR000013490

RCRA Inspection Report

Valmont Coatings Inc. dba Valmont Birmingham Galvanizing
475 Dietrich Road
Steele, Alabama 35824
St. Clair County
EPA ID: ALR000013490

June 24, 2019 at 11:30 a.m. CDT

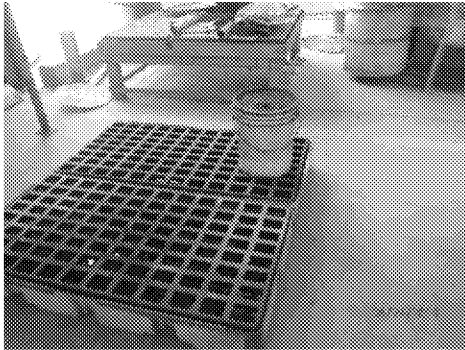
The CAA was located near the loading dock doors. The area was chained off and contained empty drums stacked on their sides and a white 5-gallon container of used oil sitting on a secondary containment pallet. The used oil container was observed not closed and not labeled. In addition, the secondary containment pallet contained oil and was not closed and not labeled. The inspectors advised Mr. Cunningham and Mr. McDonough to clean out the secondary containment pallet or label and close it per used oil regulations. No hazardous waste was observed in the area at the time.

Picture [SEQ Picture * ARABIC] – CAA used oil container

Pursuant to ADEM Admin. Code r. 335-14-17-.03 (4)(c)1., [40 C.F.R. § 279.22(c)(1)], containers and aboveground tanks used to store used oil at generator facilities must be labeled or marked clearly with the words "Used Oil."

Pursuant to ADEM Admin. Code r. 335-14-17-.03 (4)(a)1., a container holding used oil must always be closed during storage, except when it is necessary to add or remove used oil.

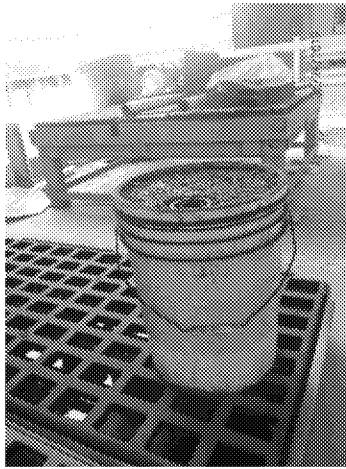
Picture [SEQ Picture * ARABIC] – CAA used oil container

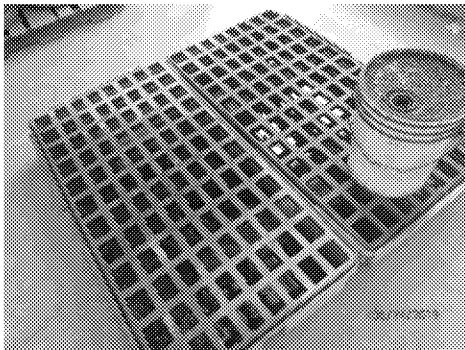
Picture [SEQ Picture * ARABIC] – CAA used oil secondary containment

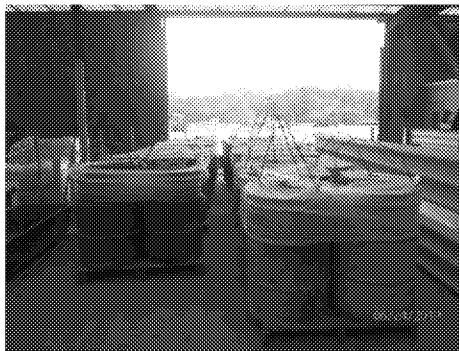
Beside the CAA were forty-four 55-gallon drums of burnt zinc from the Metaullics Zinc Recovery (MZR) System (Picture 5). The drums of burnt zinc are to be sold for reclamation of the zinc content.

Picture [SEQ Picture * ARABIC] – Burnt Zinc drums to be sold

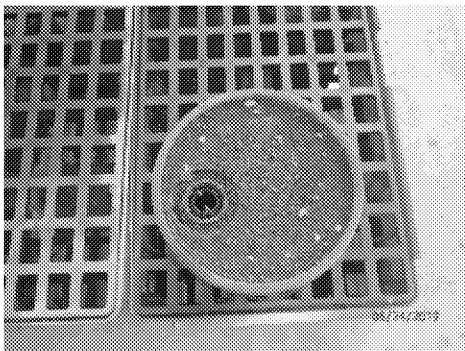
Picture [SEQ Picture * ARABIC] – CAA used oil container open

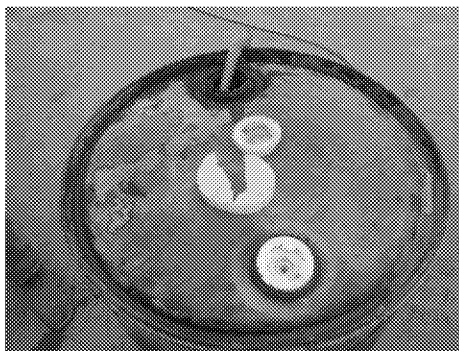
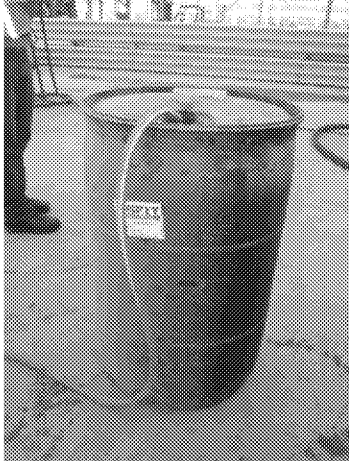
The inspectors observed a black 55-gallon drum with a green hose in the bung (Pictures 6-7). Mr. Cunningham and Mr. McDonough explained that the diesel fuel tank was moved indoors because of the constant intake of rain into the tank. The water and diesel sludge were released into the sump,

and then pumped into the drum. Mr. Cunningham said the contents of the drum would be analyzed. The inspectors explained that the satellite accumulation area (SAA) drum must be labeled “hazardous waste” and “pending analysis” and dated until the results are received.

Picture [SEQ Picture * ARABIC] – Sump HW diesel and water drum

Pursuant to ADEM Admin. Code r. 335-14-3-.01(5)(a)4 [40 C.F.R. § 262.15(a)(4)], which is a condition of the SAA Permit Exemption, a generator is required to keep containers of hazardous waste closed at all times during accumulation, except when adding, removing, or consolidating waste; or when temporary venting of a container is necessary for the proper operation of equipment, or to prevent dangerous situations, such as build-up of extreme pressure.

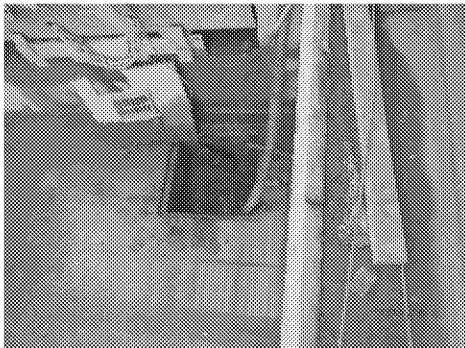
Picture [SEQ Picture * ARABIC] – Sump full of diesel and water

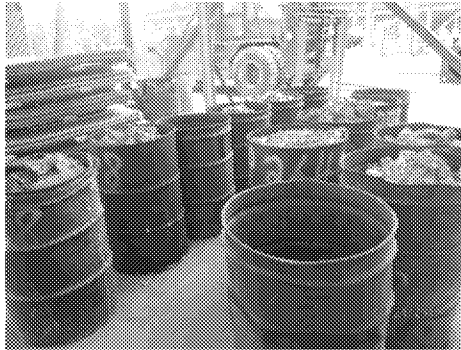
The galvanizing process is located between the two product areas. The inspectors observed thirteen 55-gallon drums of zinc dross (Picture 9) and one 55-gallon drum of burnt zinc (Picture 10) to be sold for reuse.

Picture [SEQ Picture * ARABIC] – Zinc Dross drums to be sold

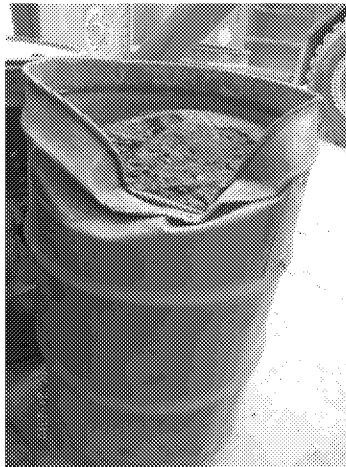
Picture [SEQ Picture * ARABIC] – Burnt Zinc drum to be sold

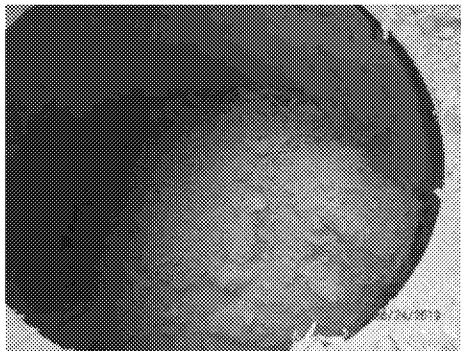
The zinc skims are removed from the zinc kettle manually using basket (Picture 11). The scooped-out skims are placed into a container for the MZR (Picture 13). The MZR system separates the zinc dross using high temperature and a rotating drum to separate out the impurities in the dross. Once the zinc is molten it is poured into a mold to solidify (Picture 12).

Picture [SEQ Picture * ARABIC] – Zinc skimmings from Kettle

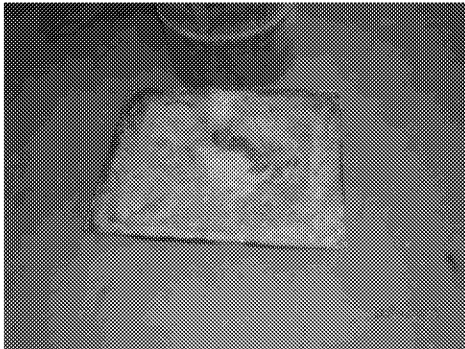
Picture [SEQ Picture * ARABIC] – MZR zinc ingot

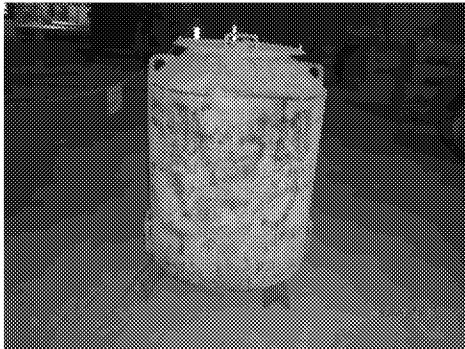
Picture [SEQ Picture * ARABIC] – MZR barrel

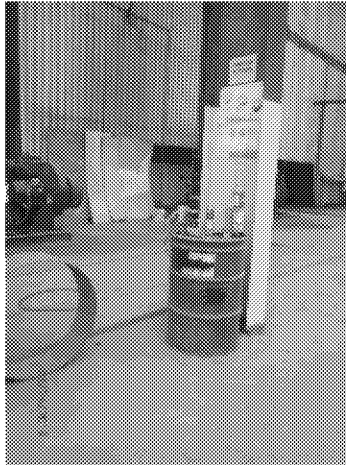
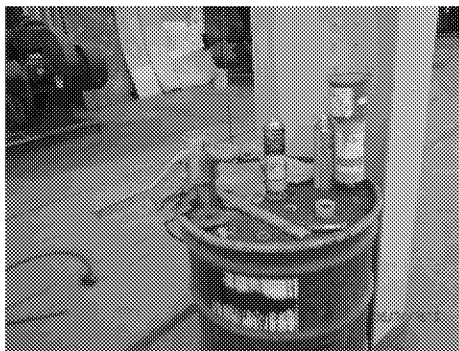
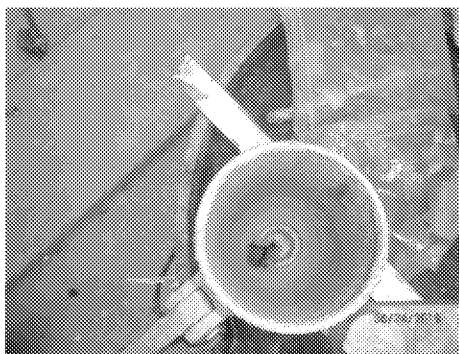
The inspectors observed a spent aerosol can puncture system on a 55-gallon drum. The drum was not labeled, and the puncture system attached to the bung hole was not closed (Pictures 14-16). Mr. Cunningham explained that the zinc paint residue collected is not disposed of but reused to touch up the poles. The residue is not a waste.

Picture [SEQ Picture * ARABIC] – Puncture can station

Picture [SEQ Picture * ARABIC] – Puncture can system and residue drum

Picture [SEQ Picture * ARABIC] – Puncture can

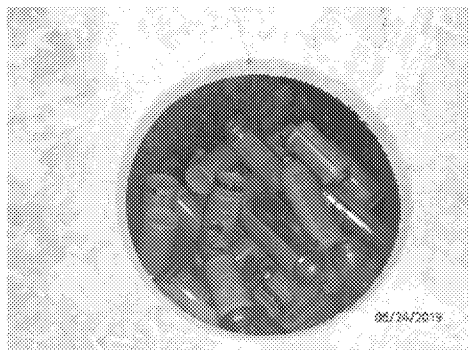
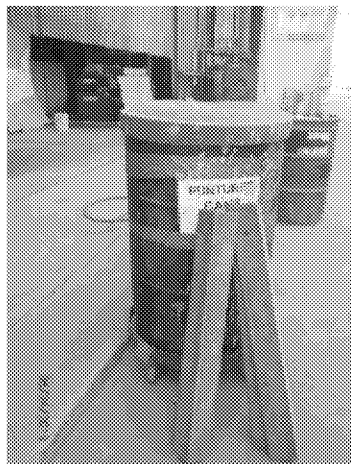
Near to the spent aerosol can drum was a 55-gallon drum used to collect scrap cans that had been punctured (Pictures 17-18). A 55-gallon drum labeled "Spray Cans" was contained punctured cans and trash instead of unpunctured spent aerosol cans (Pictures 19-20). The inspectors also observed a 55-gallon drum of one-gallon zinc paint cans with dried residue (Picture 21).

Picture [SEQ Picture * ARABIC] – Punctured cans drum

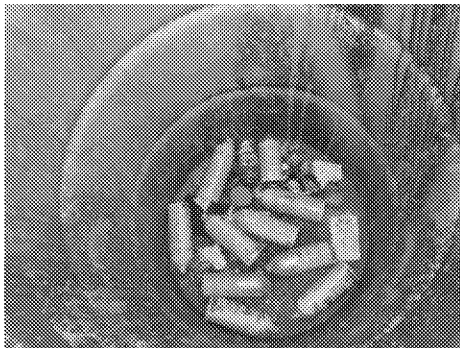
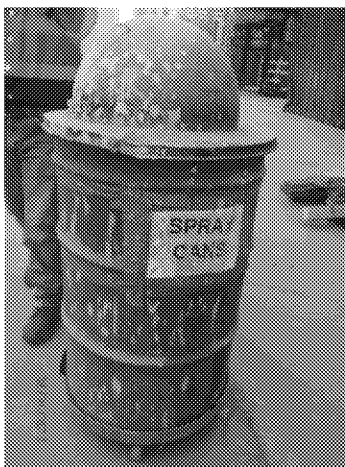
Picture [SEQ Picture * ARABIC] – Spray Cans drum for unpunctured cans

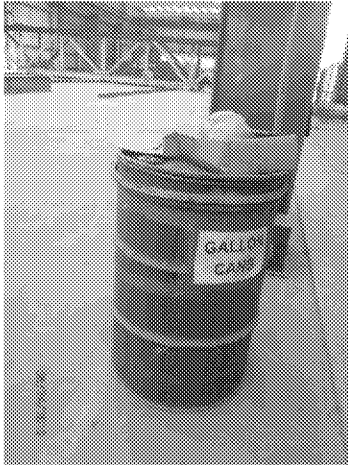
Picture [SEQ Picture * ARABIC] – Gallon paint cans drum

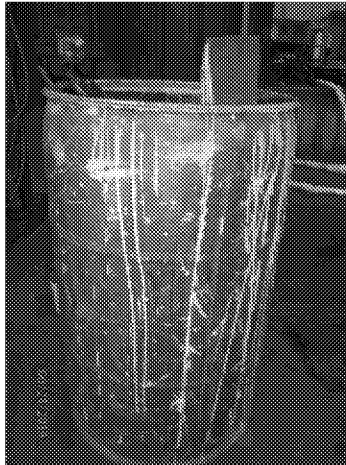
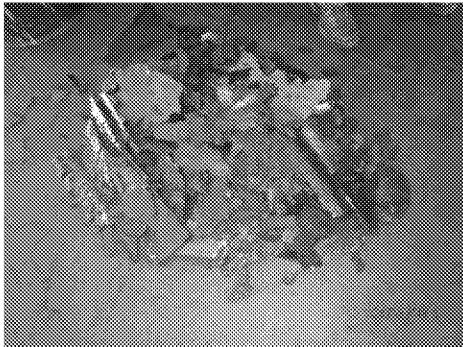
Depending on the customers, polyvinyl two-part epoxy paint is used. The inspectors observed in the Polyvinyl Area dried overspray residue on the floor, scraped up in a pile and in a placed a 55-gallon drum (Pictures 22-24). Also, four 55-gallons of reclaimed blast media shot was stored in this area (Picture 25). The shot will be put back into the process and reused.

Picture [SEQ Picture * ARABIC] – Polyvinyl overspray discarded

Picture [SEQ Picture * ARABIC] – Polyvinyl overspray to be discarded

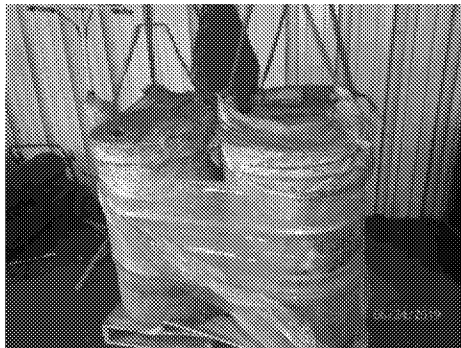
Picture [SEQ Picture * ARABIC] – Reclaimed shot blast to be reused

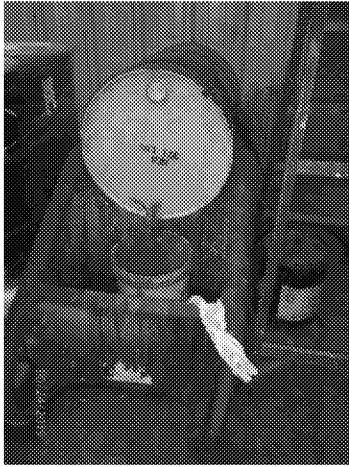
The inspectors observed a 55-gallon drum of methyl ethyl ketone (MEK) with a facet attached to the bung (Picture 26). The secondary containment under the drum was filled with MEK and a container filled with MEK and two brushes (Picture 27). The MEK is used to clean the paint brushes and the paint gun. Small containers of MEK used for cleaning was observed on the worktop (Picture 28).

Picture [SEQ Picture * ARABIC] – Paint Room MEK drum

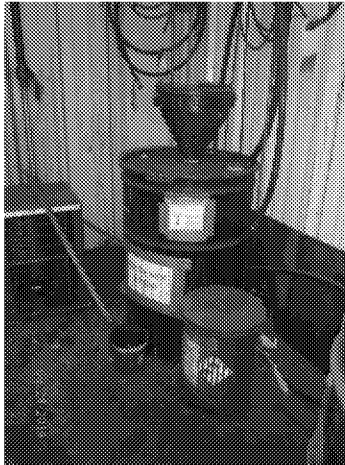
The inspectors also observed a 55-gallon SAA drum of waste MEK and paint with a red funnel that was not closed, a red SAA step can of waste MEK contaminated rags and personal protective equipment and a half gallon container of waste MEK and paint that was not closed or labeled (Pictures 29-32).

Picture [SEQ Picture * ARABIC] – Paint Room HW MEK containers

Pursuant to ADEM Admin. Code r. 335-14-3-.01(5)(a)4 [40 C.F.R. § 262.15(a)(4)], which is a condition of the SAA Permit Exemption, a generator is required to keep containers of hazardous waste closed at all times during accumulation, except when adding, removing, or consolidating waste; or when temporary venting of a container is necessary for the proper operation of equipment, or to prevent dangerous situations, such as build-up of extreme pressure.

Pursuant to ADEM Admin. Code r. 335-14-3-.01(5)(a)5 [40 C.F.R. § 262.15(a)(5)], which is a condition of the SAA Permit Exemption, a generator is required to mark or label its containers (i) with the words "Hazardous Waste" and (ii) with an indication of the hazards of the contents.

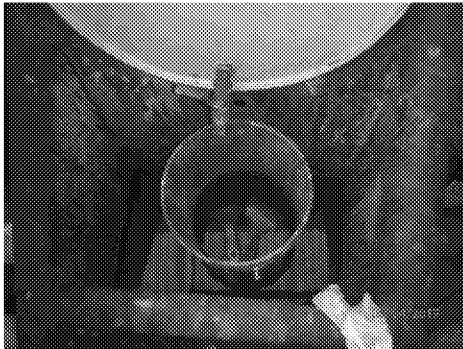
Picture [SEQ Picture * ARABIC] – Paint Room MEK brush cleaner

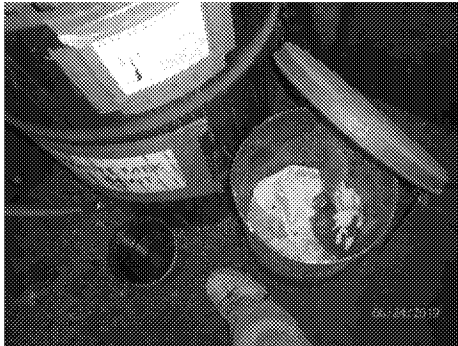
Picture [SEQ Picture * ARABIC] – Paint Room HW MEK rags/PPE

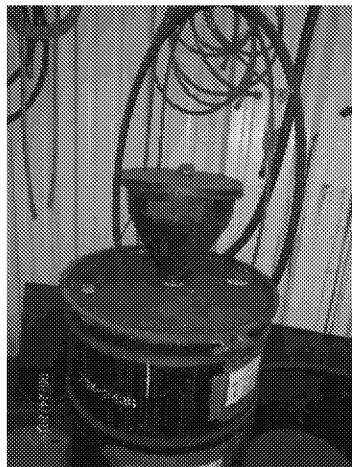
Picture [SEQ Picture * ARABIC] – Paint Room HW
MEK drum

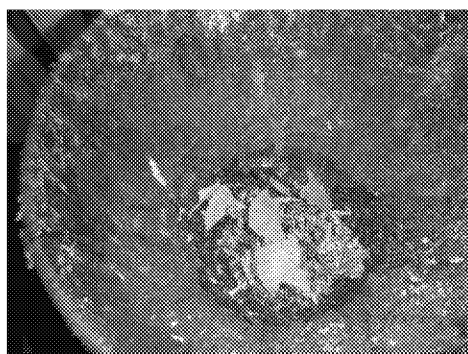
Picture [SEQ Picture * ARABIC] – Paint Room HW
MEK drum funnel
